National Dam Inspection Program.

Bear Creek Dam (PA-00607),
Schuylkill River Basin, Bear Creek,
Carbon County, Pennsylvania.
Phase I Inspection Report.

BEAR CREEK DAM
CARBON COUNTY, PENNSYLVANIA
NATIONAL I.D. NO. PA 00607

PHASE I INSPECTION REPORT NATIONAL DAM INSPECTION PROGRAM

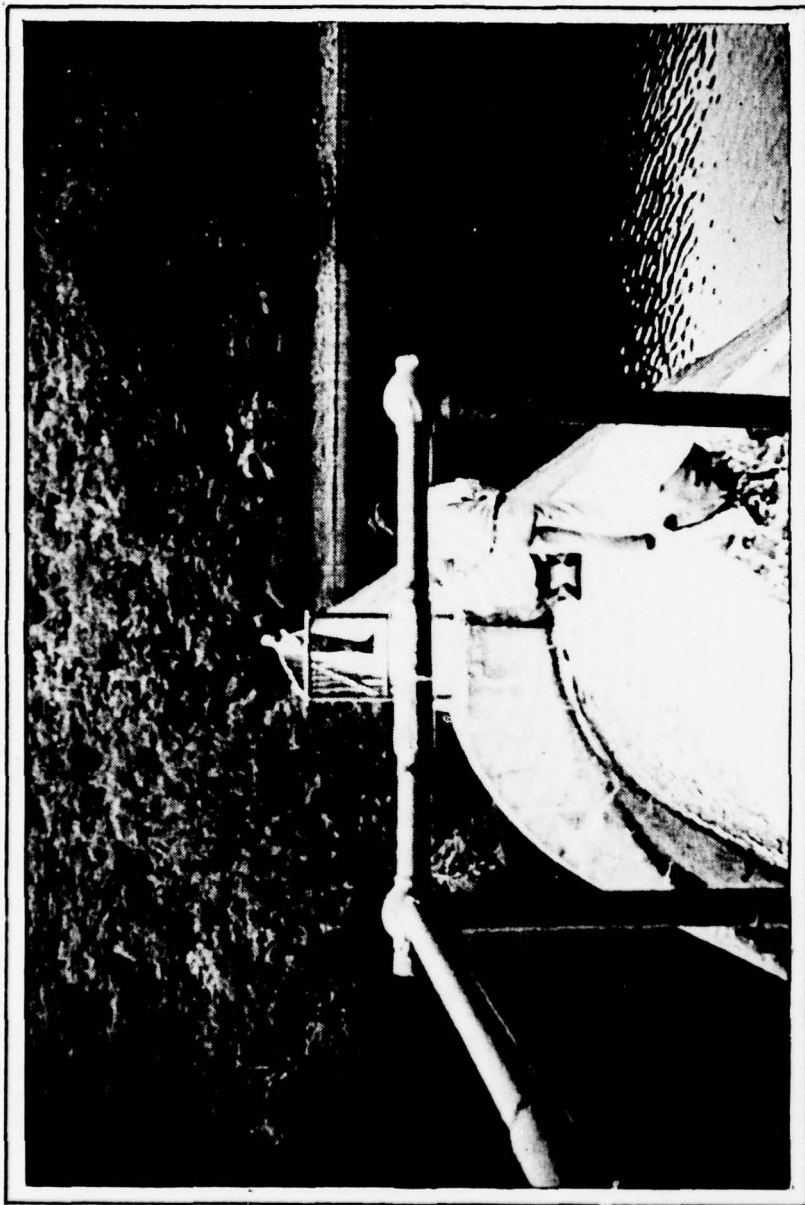
PHOTOGRAPH NO. 2

2. Spillway. The spillway was inspected and observed to be in good condition. There was some minor spalling and concrete deterioration and areas that had been patched. The stilling basin was observed to be dry, in fair condition, with some concrete deterioration. The spillway channel to the first pond downstream was in fair condition with some deterioration noted.

VIEW OF SPILLWAY. NOTE SPALLING AND
PATCH WORK ON SURFACE.

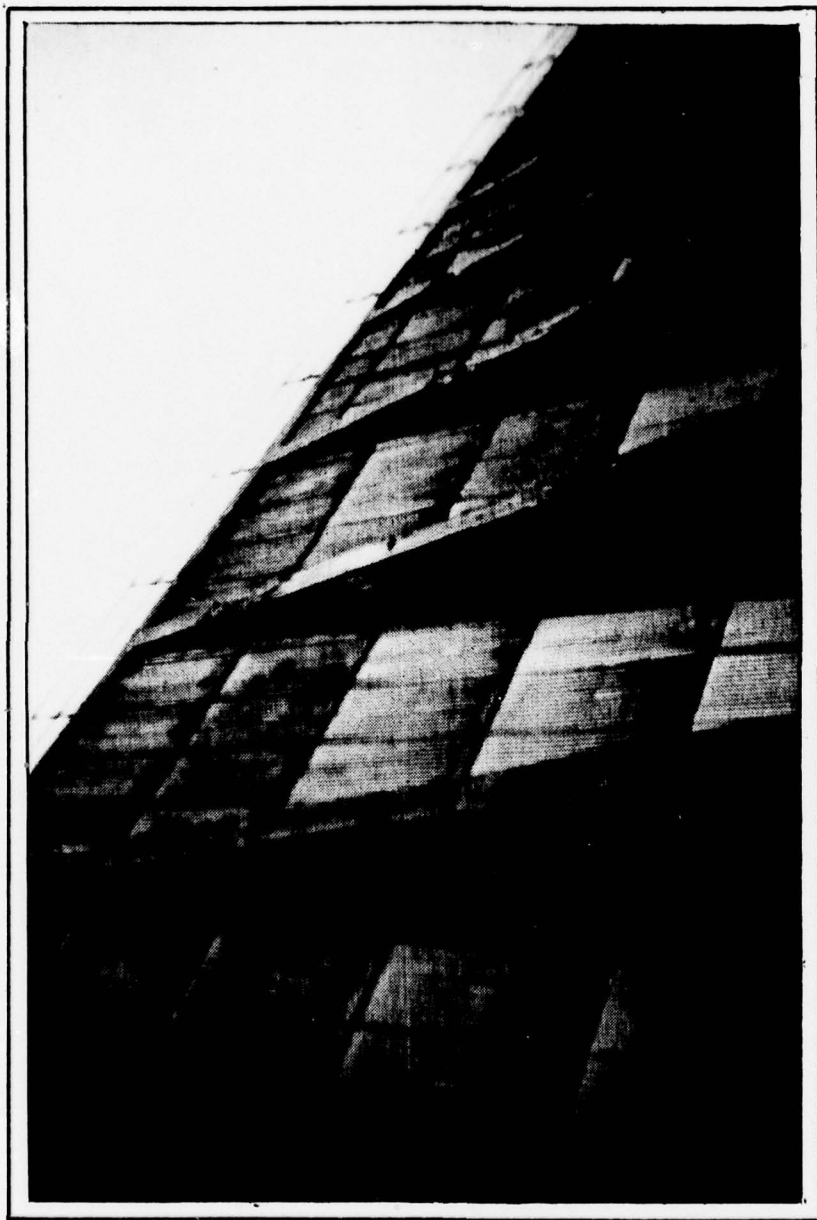
PHOTOGRAPH NO. 4

DOWNSTREAM BUTTRESSES WITH ASBESTOS
FACIAL PLATES.

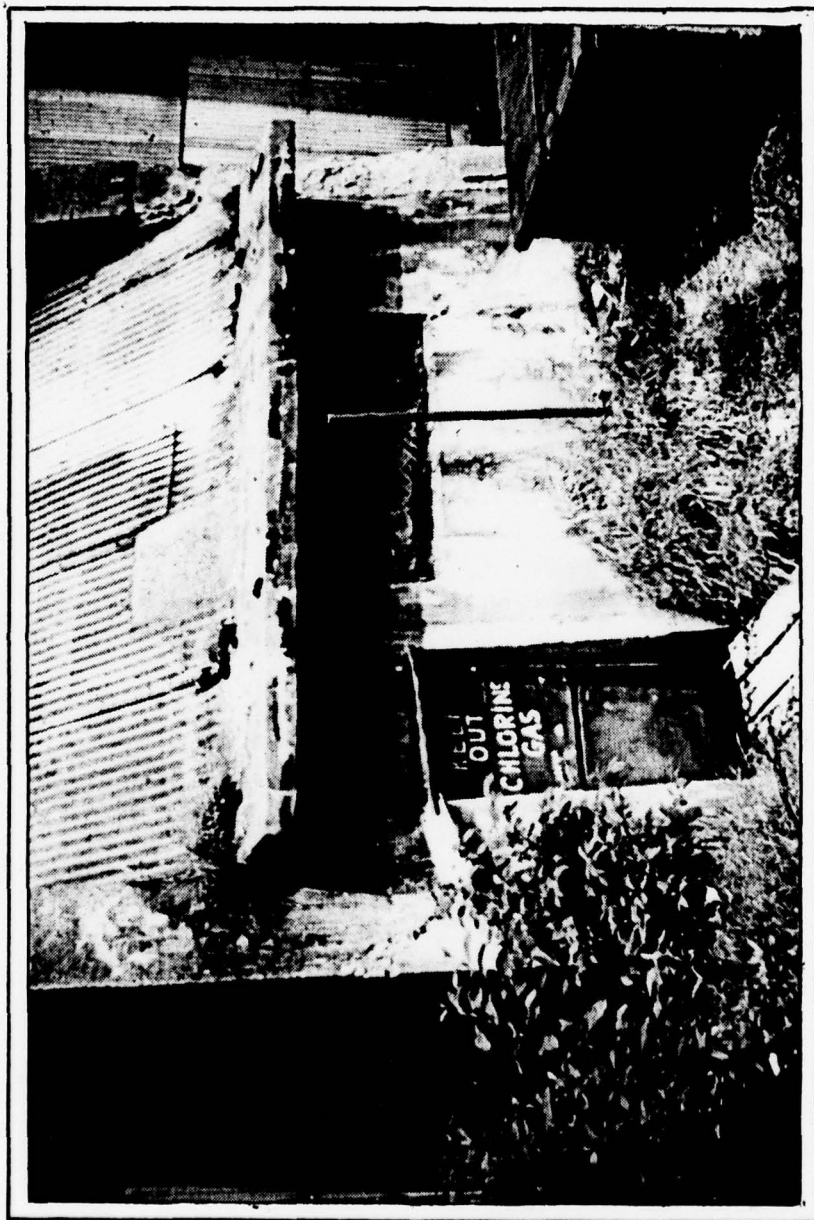
WATER TREATMENT (CHLORINE) BUILDING.
NOTE BUTTRESS DETERIORATION.

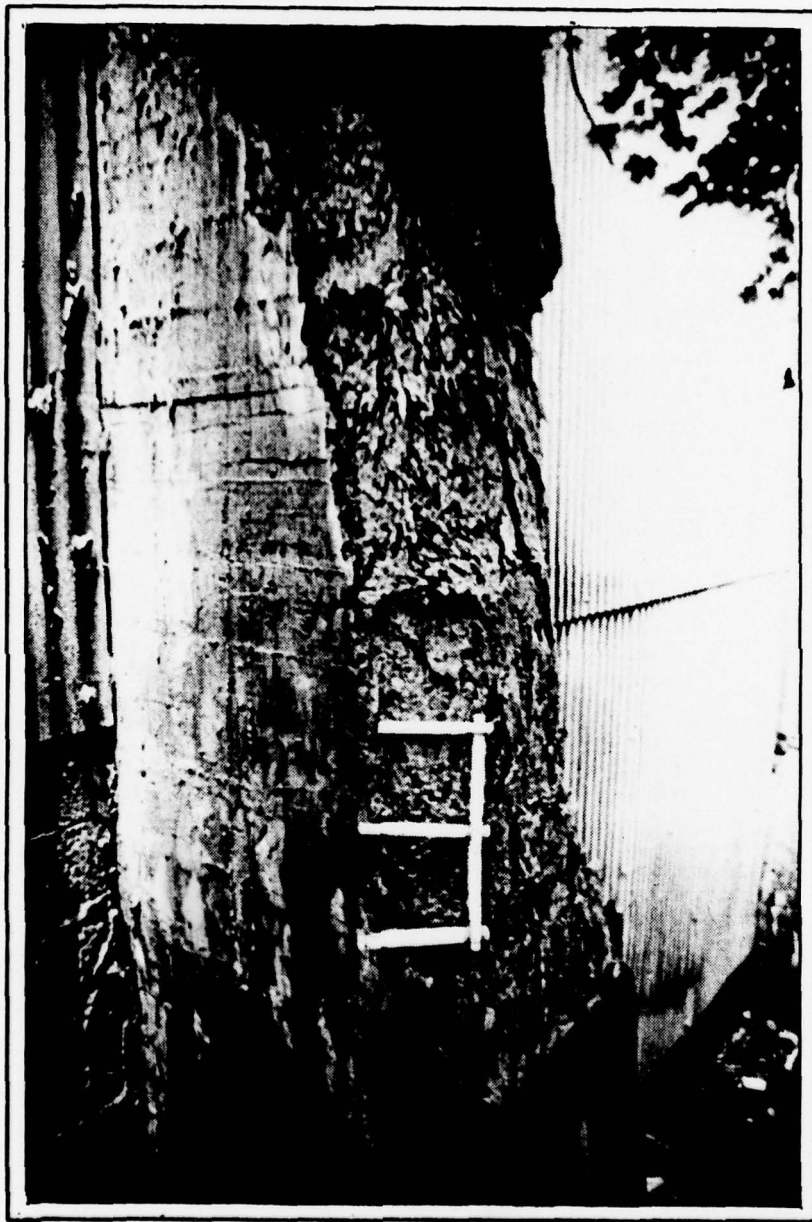
PHOTOGRAPH NO. 8

In summary, the visual survey of the dam disclosed that the concrete is in poor condition with significant spalling and deterioration. Typical photographs of this deterioration are shown in Appendix D as Photographs 8 through 12. Seepage was noted at several locations along the structure, along buttress walls and, occasionally beneath the foundation.

Visual inspection of the buttress walls disclosed that the concrete was spalled and, in some cases, the reinforcing steel was exposed and deteriorated. A close inspection of the concrete showed that much of the coarse aggregate consisted of crushed coal and not high quality stone. Therefore, it is concluded that additional structural evaluations are required. Considering the condition of the structure and the materials used for the construction, there is a good possibility that overtopping could induce structural collapse of the dam. This possibility can only be determined after a detailed structural evaluation is completed.

SPALLED CONCRETE OF BUTTRESS
NUMBER 3. SEE PLATE 2 APPEN-
DIX E FOR BUTTRESS LOCATION.

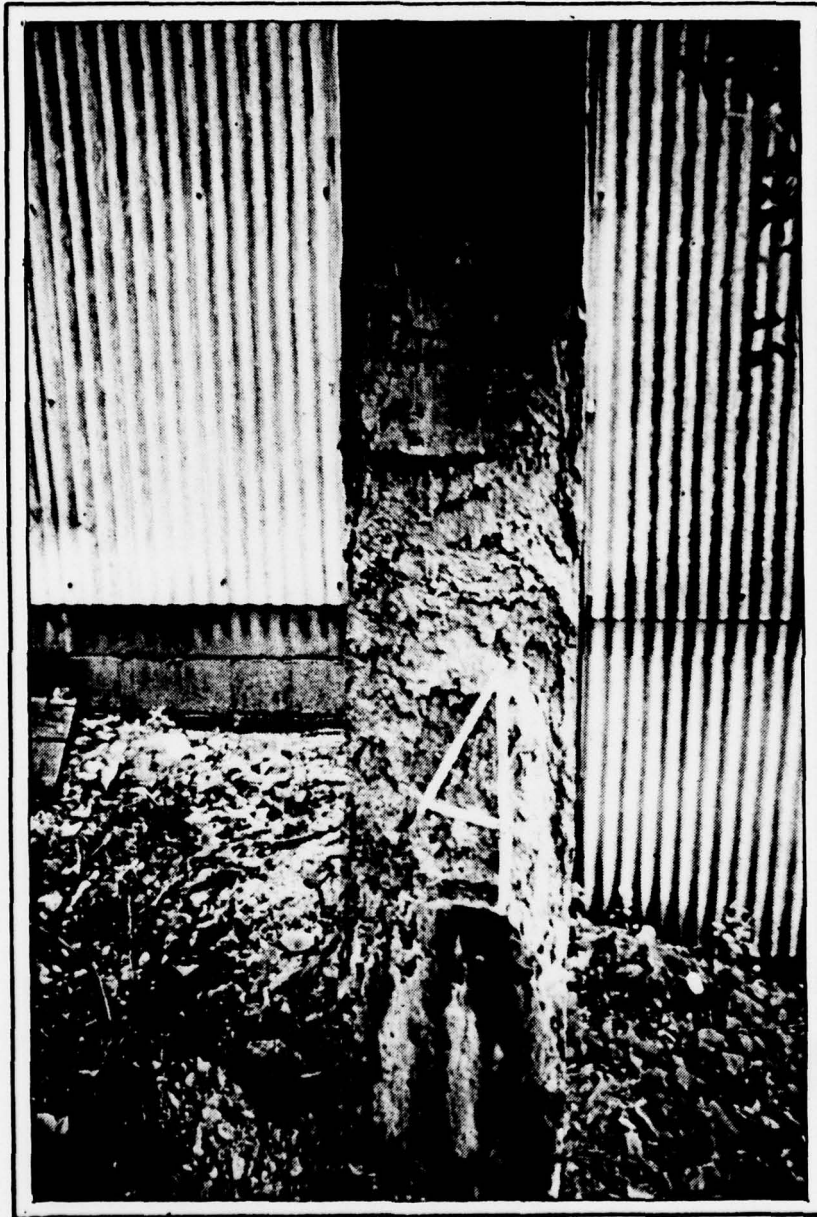
SPALLED CONCRETE OF BUTTRESS
NUMBER 4. SEE PLATE 2 APPEN-
DIX E FOR BUTTRESS LOCATION.

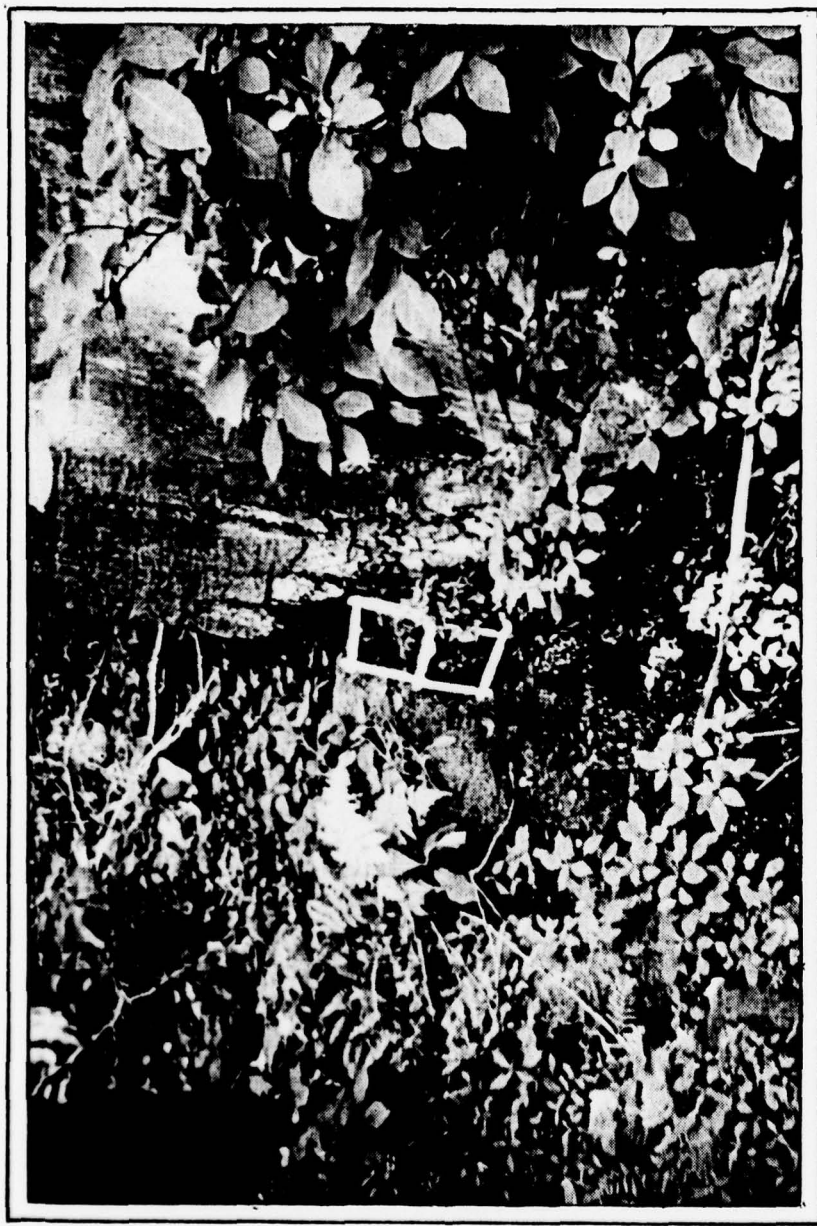
PHOTOGRAPH NO. 10

SEEPAGE BENEATH BUTTRESS NUMBER 8.
FLOW WAS CLEAR.

3. Underseepage and seepage through cracks should be evaluated and monitored, and the effect of underseepage on the long term stability of the dam determined.

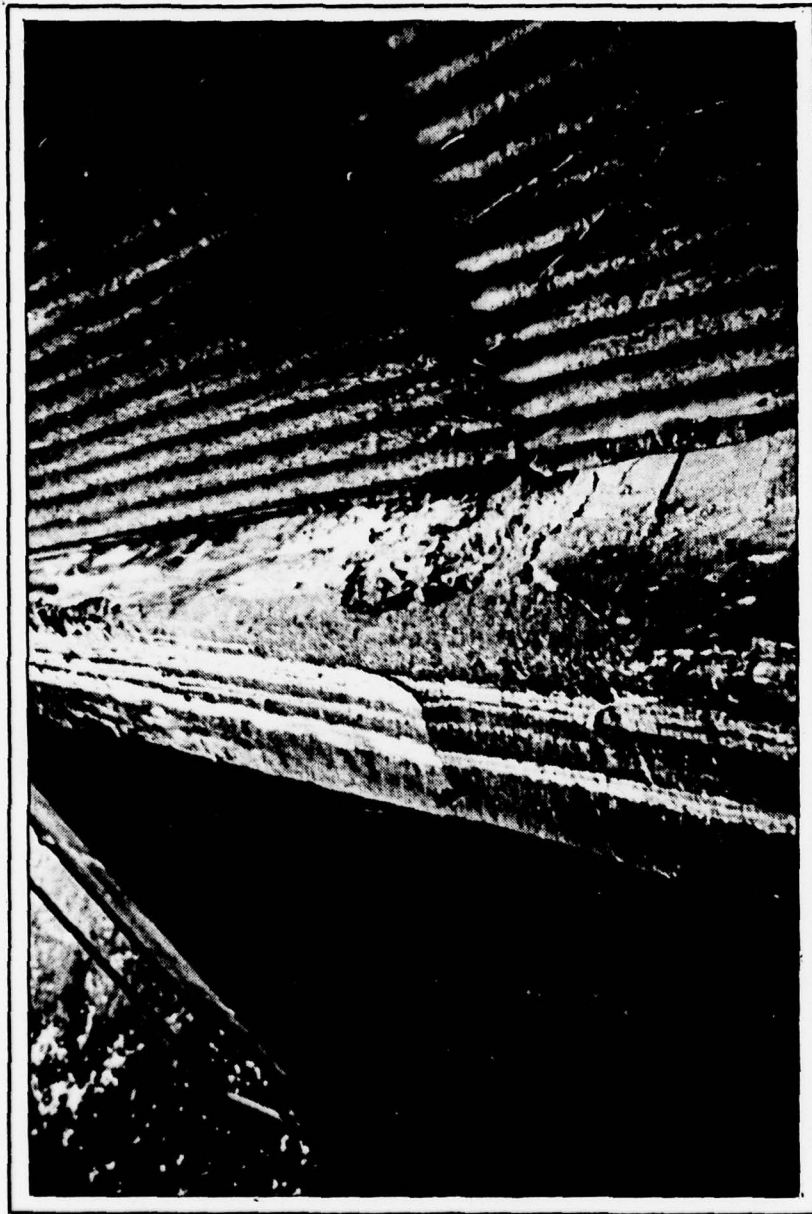
PHOTOGRAPH NO. 11

SPALLED CONCRETE OF BUTTRESS NUMBER 4.

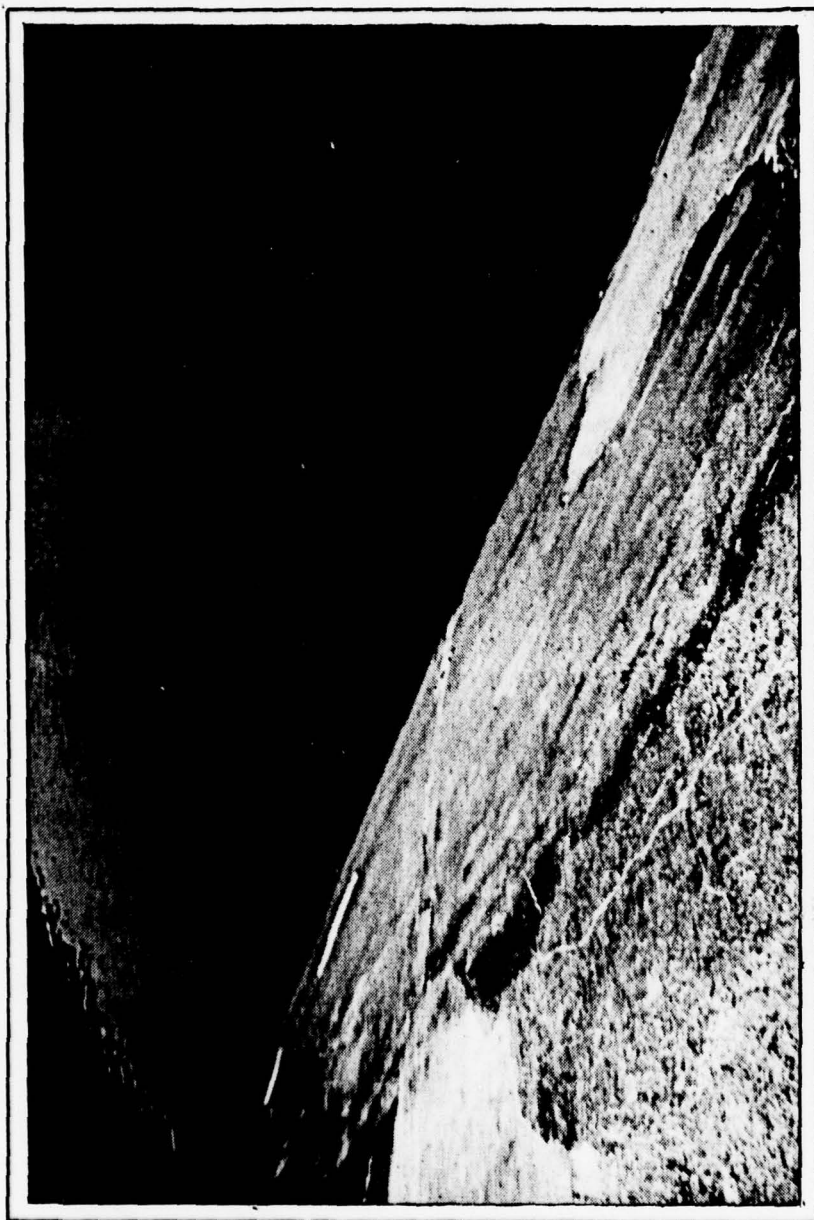
PHOTOGRAPH NO. 14

PATCHING OF UPSTREAM FACE OF
DAM.

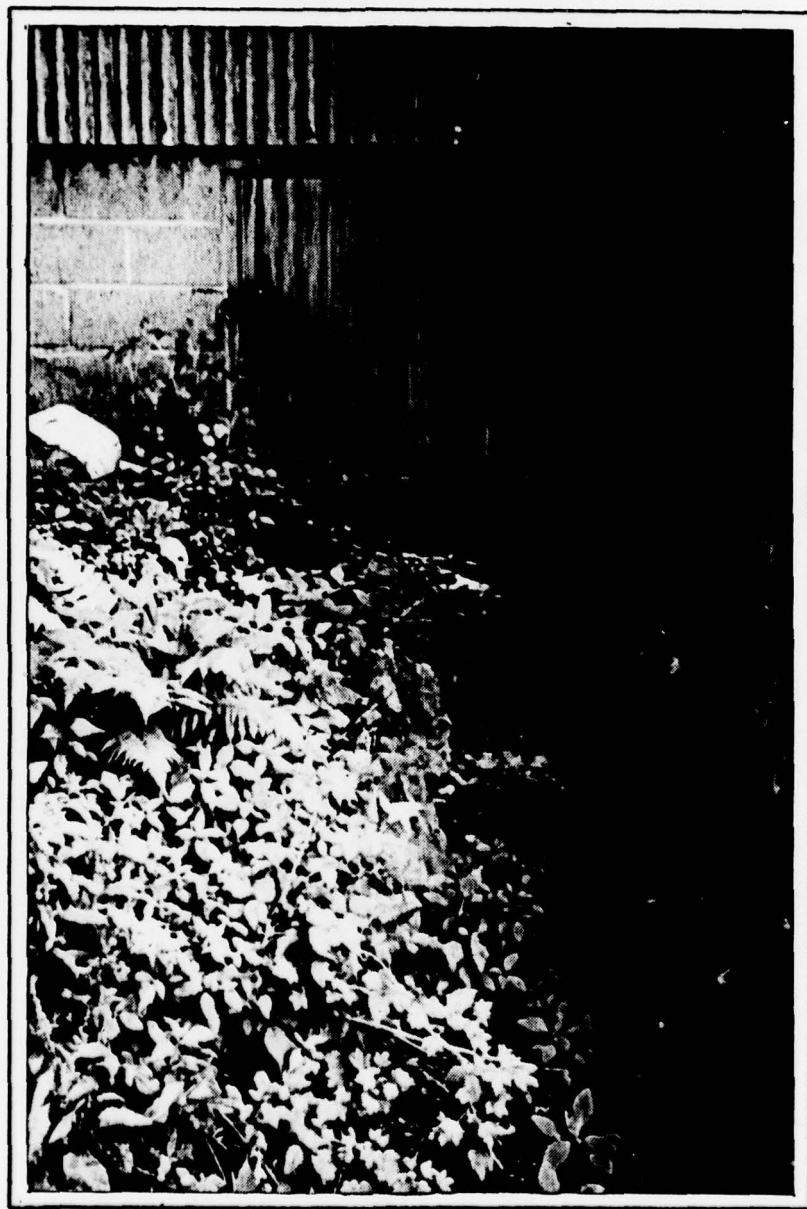
PHOTOGRAPH NO. 15

TYPICAL SEEPAGE ADJACENT
TO BUTTRESSES. ALL SEEP-
AGE WAS CLEAR.

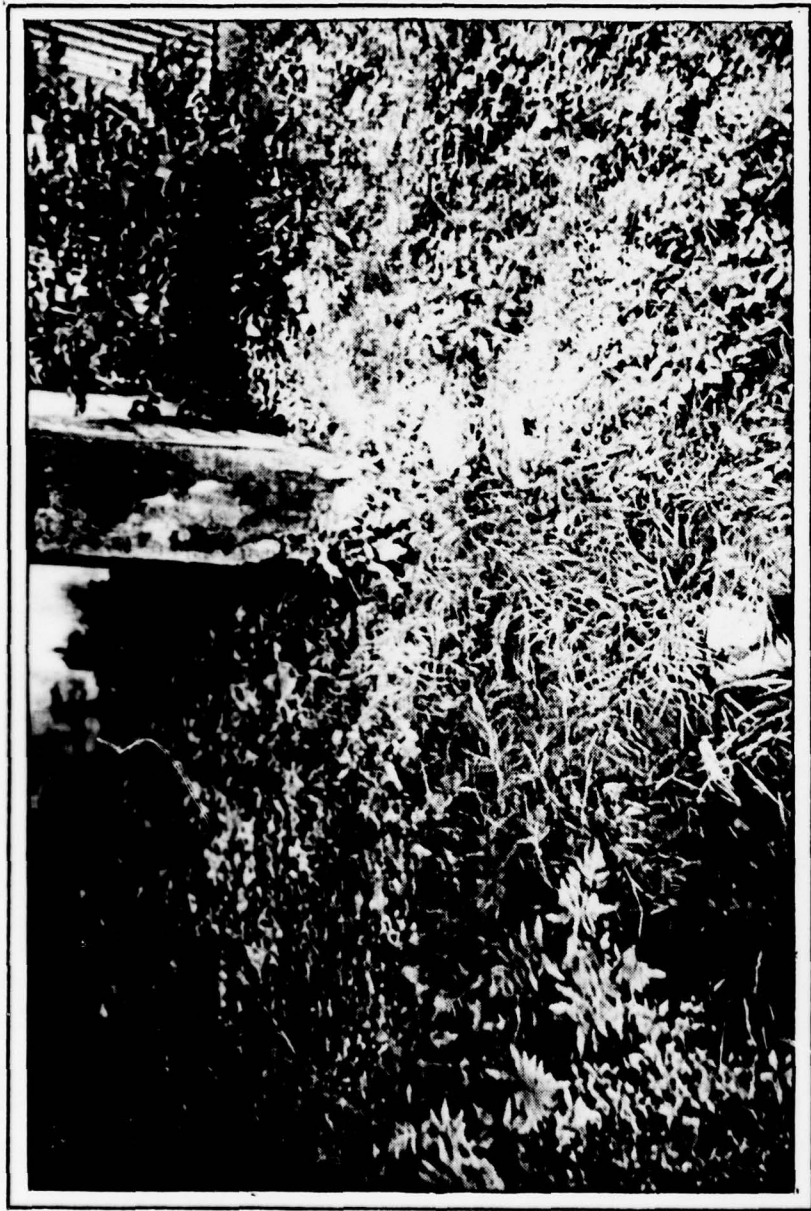
PHOTOGRAPH NO. 16

TYPICAL SEEPAGE CHANNELS BELOW
DAM.

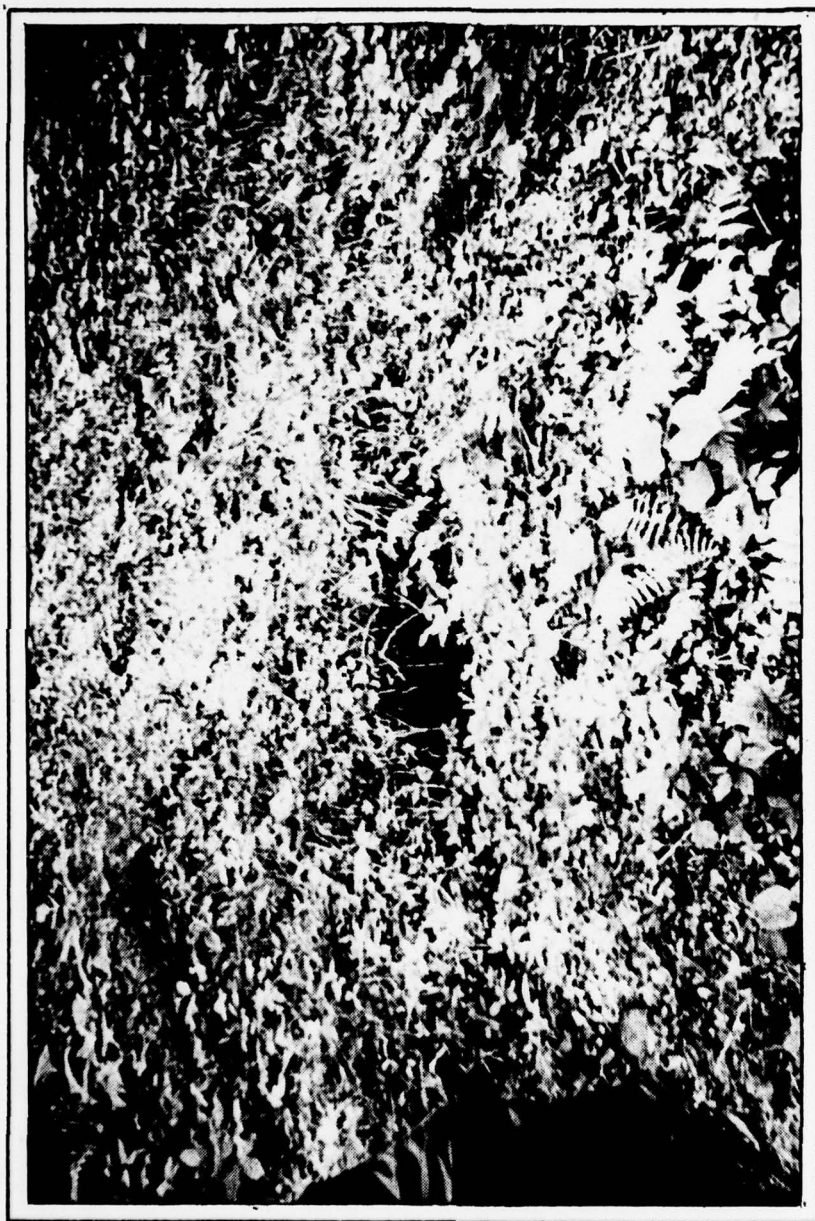
PHOTOGRAPH NO. 17

DETERIORATED DOWNSTREAM MATERIALS
WITH ANIMAL HOLES/SEEPAGE HOLES.

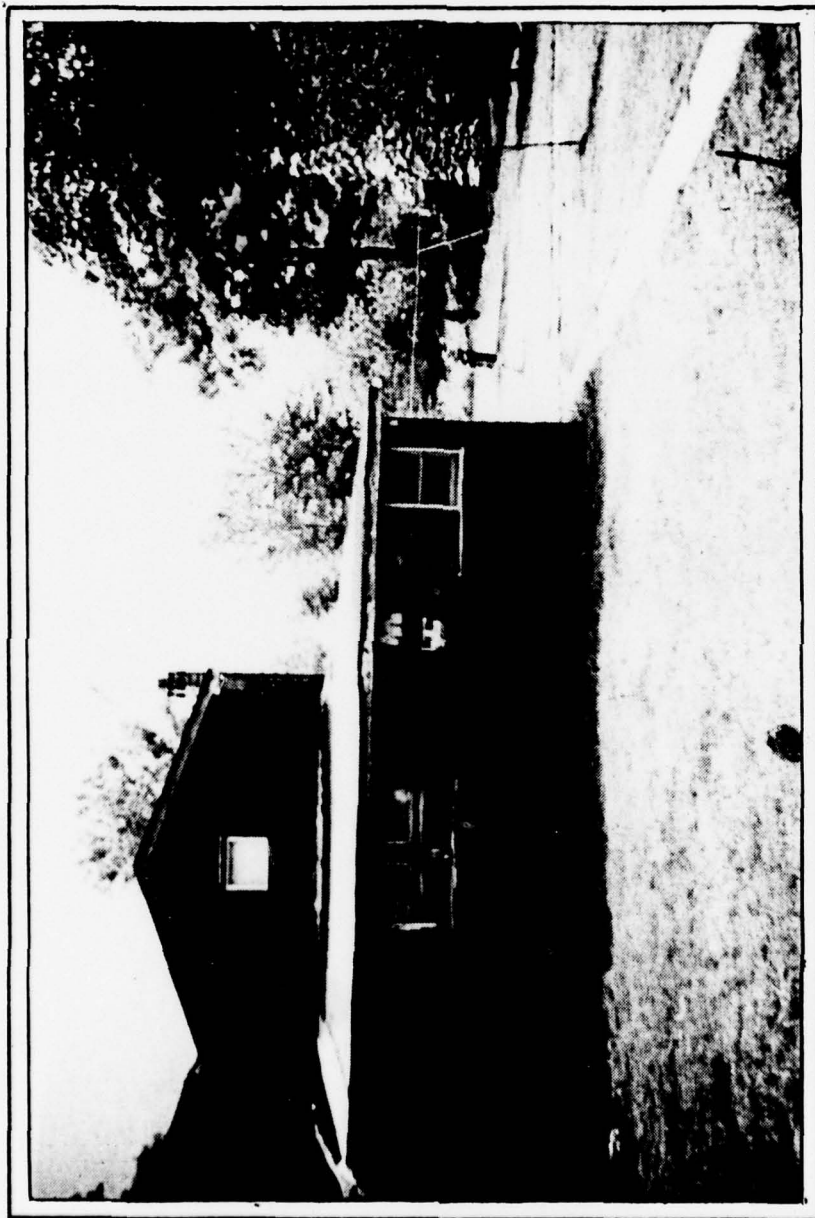
PHOTOGRAPH NO. 18

VIEW OF ONLY HOUSE DOWNSTREAM IN
DIRECT PATH OF FLOOD WAVE IN EVENT
OF FAILURE. DWELLING IS USED AS A
SUMMER HOME.

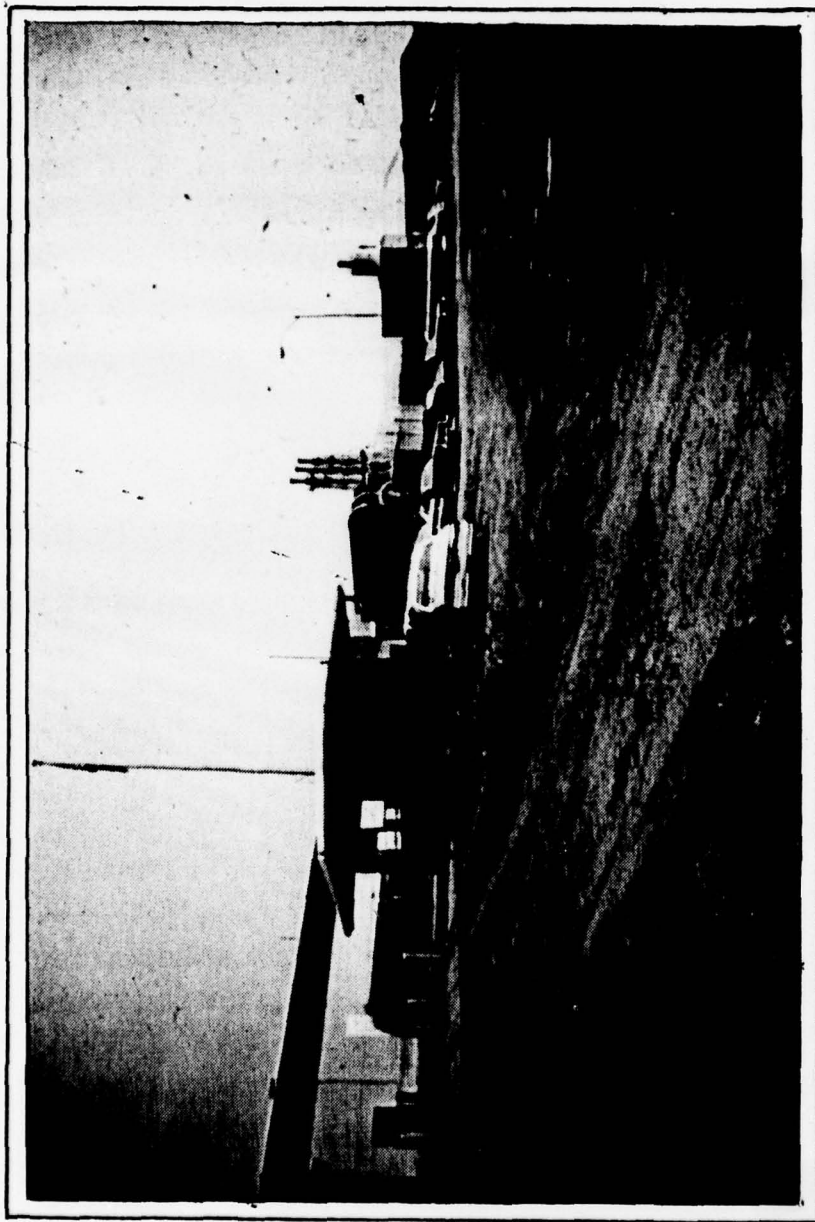
PHOTOGRAPH NO. 19

CASTING FACTORY DOWNSTREAM OF DAM
THAT WOULD BE AFFECTED IN EVENT OF
DAM FAILURE.
